COMMERCIAL INSPECTION REPORT

1234 Main Street, Los Angeles, ,

Inspector: Garrett Martell CMI

Date of Inspection: 8/17/2023

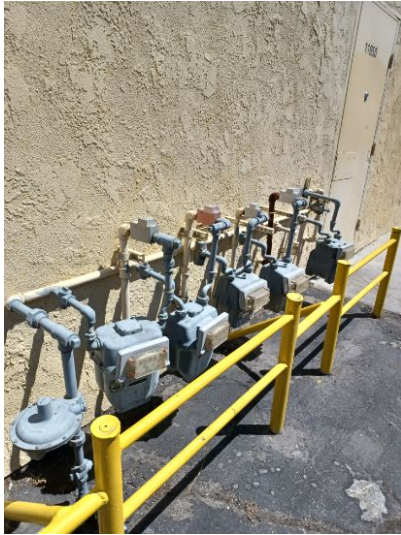
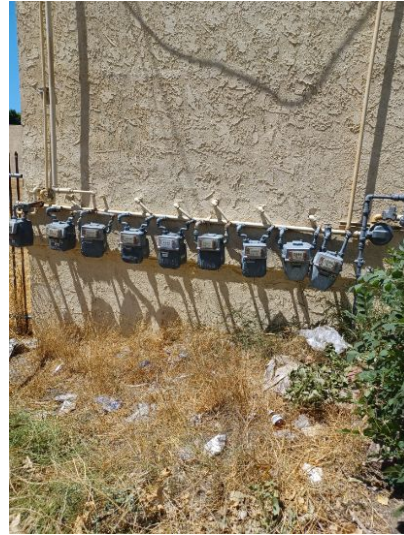
There are areas of rusty and deteriorated gas piping on the property. Recommend paint seal

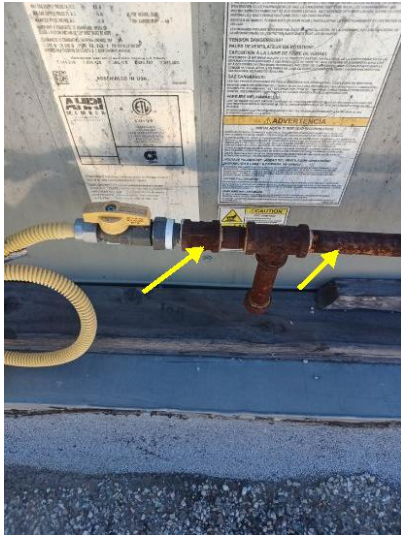
There are areas of rusty and deteriorated gas piping on the property. Recommend paint seal

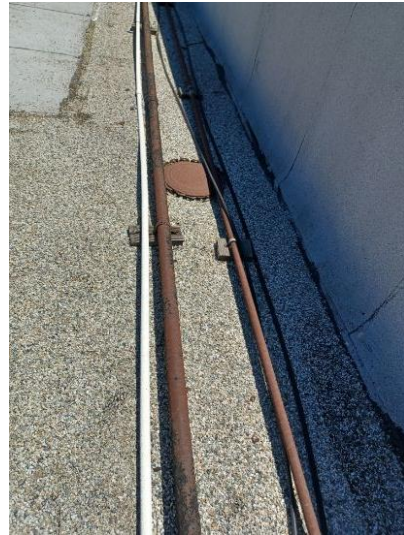
There are areas of rusty and deteriorated gas piping on the property. Recommend paint seal

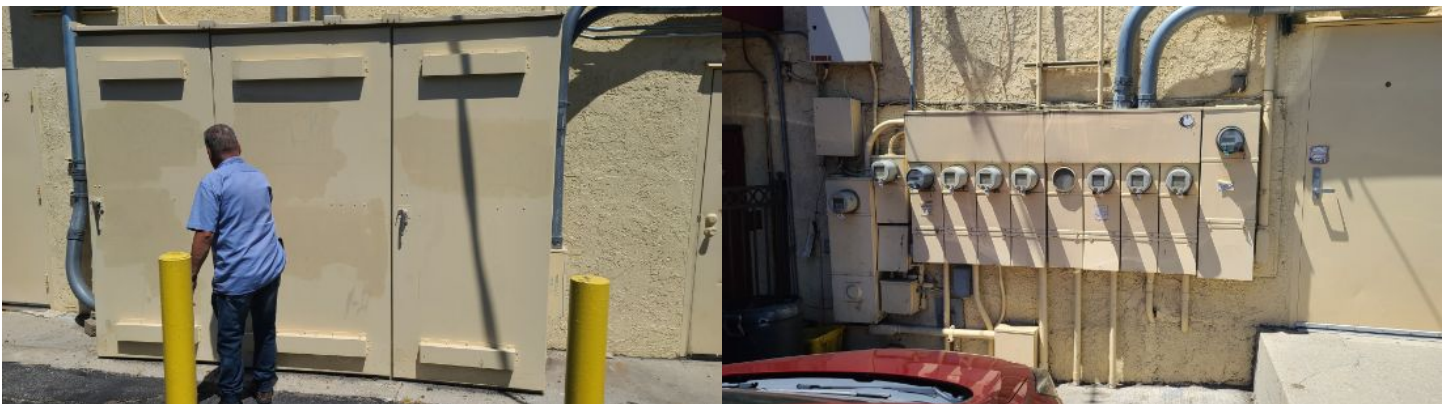
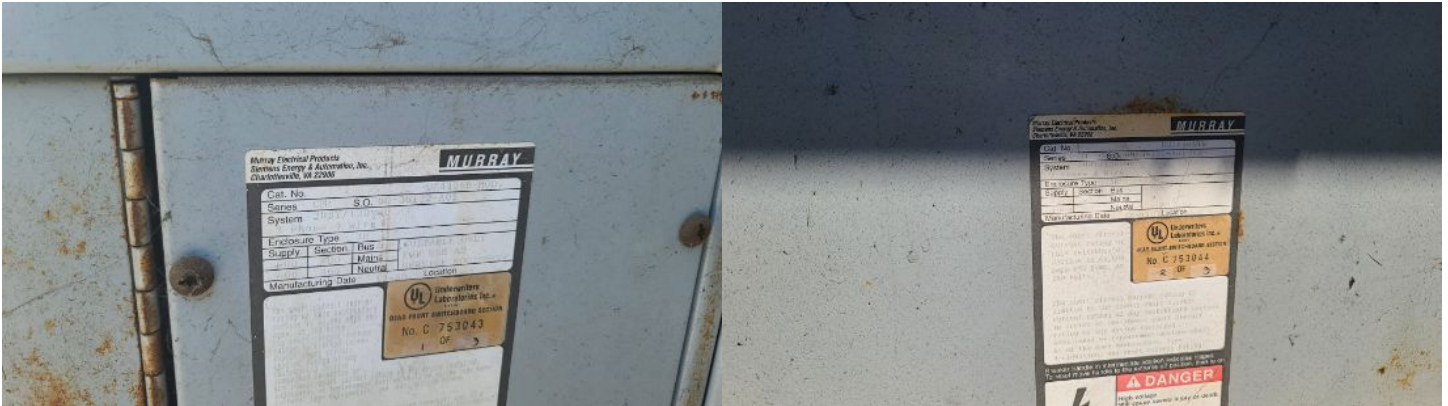
The panel cover is missing inside a few of the electrical boxes at the rear building and the live wiring and circuits are exposed when the outside cover is opened

There is one Federal Pacific panel at the rear building

This panel is an older Federal Pacific system which have been known to have breakers that fail to trip properly when compared with similar panels of the same age and considered a potential fire safety concern, further evaluation is recommended by a licensed electrician to that any repairs or replacements may be made

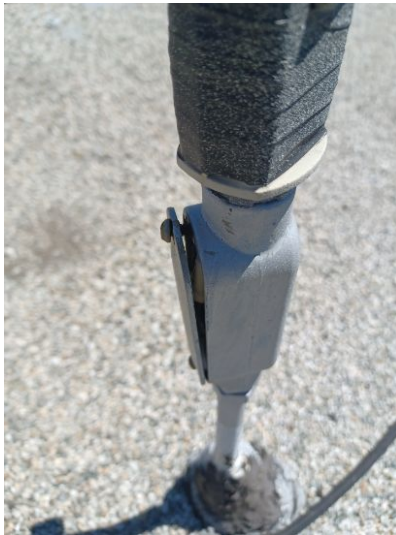
Open conduit on the roof.

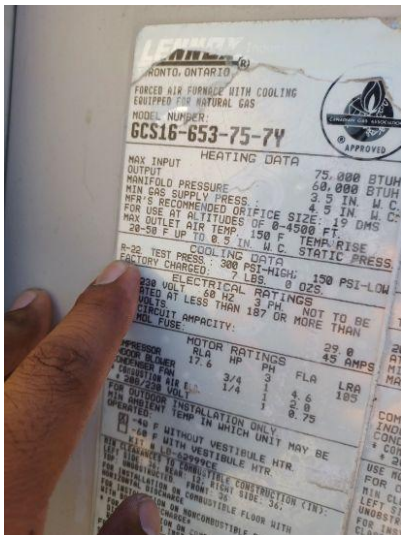
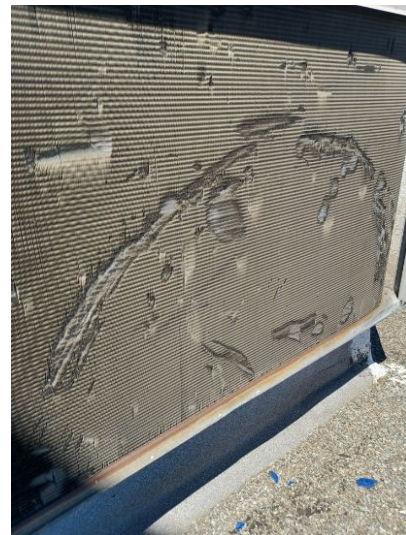
Damaged fins noted to units

It was noted that some of the HVAC systems installed use R22 refrigerant. R22 is being phased out due to its impact on the environment and its contribution to ozone depletion. The production of R22 has been gradually decreasing over the years. This may cause the systems to become more difficult or expensive to service. If further information is needed, a consultation with an HVAC contractor is recommended.

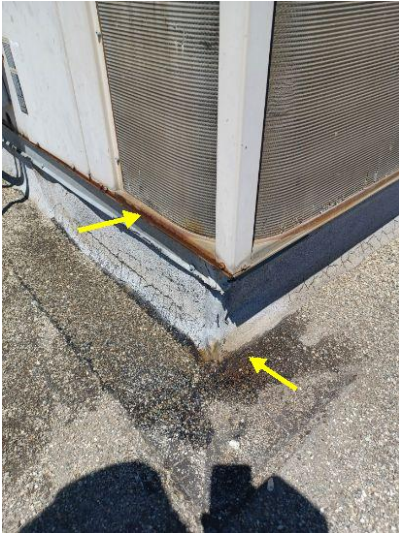
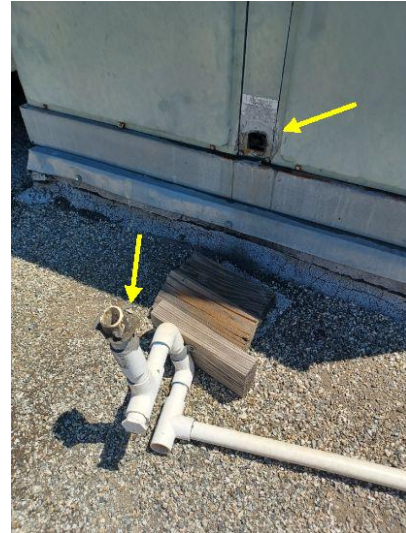
It was noted that a few of the HVAC system had water pooling underneath the housing of the package unit. This is an indication of poor drainage of the condensation line and could lead to damage to the metal flashing pan or even leakage into the below business space. Evaluation is recommended.

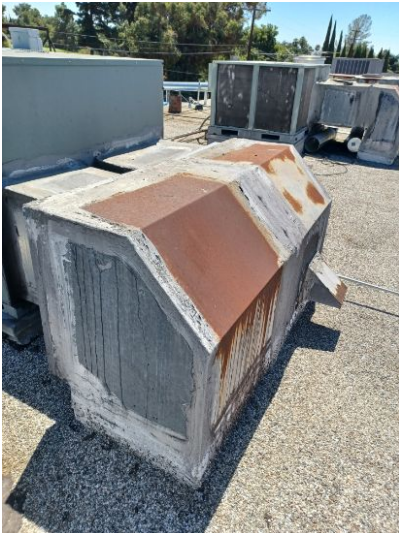
There are ducts installed on the roof. These are exposed to the weather and the waterproof coating and sealer covering them is deteriorating

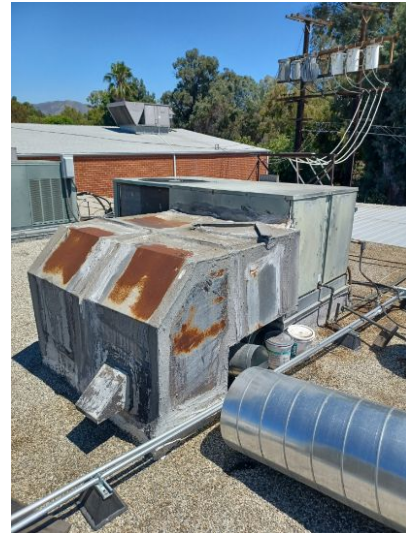
There are ducts installed on the roof. These are exposed to the weather and the waterproof coating and sealer covering them is deteriorating

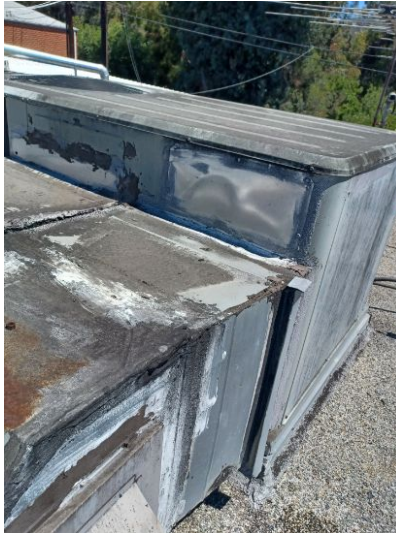
There are systems no longer operating. Removal recommended if no longer in use

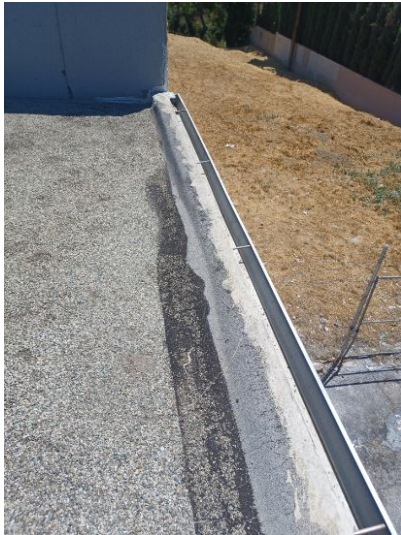
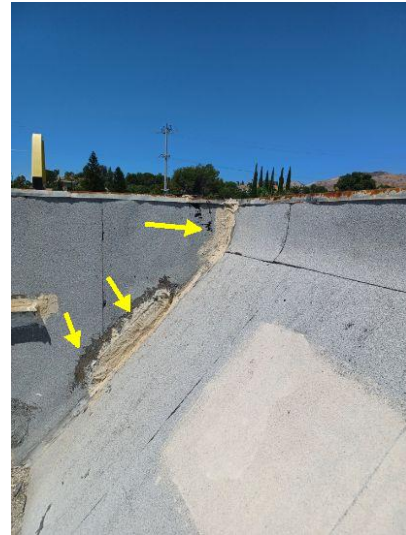
There are bubbled areas of roofing material. This could be an indication that some moisture has gotten under the material or that the sheathing installed under shingles is deteriorated or poorly installed.

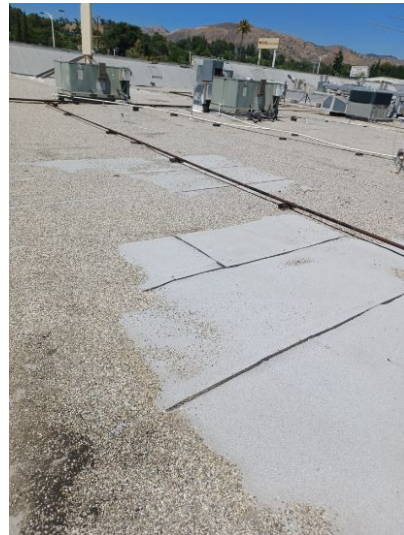
Mexican Grill Building

There are patches on the roof, these are a possible indication that there have been problems with the roof at some point in time. The seller could be consulted on the past of this area.

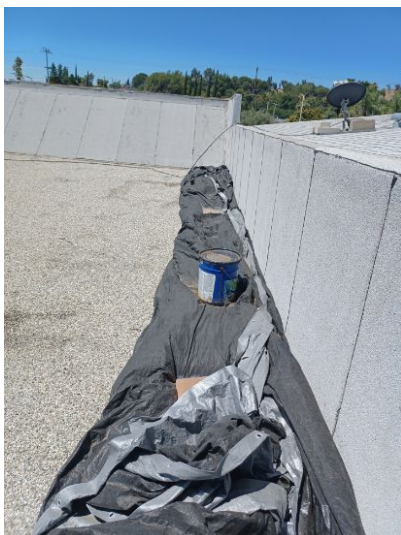
Large tarp on the Mexican grill roof

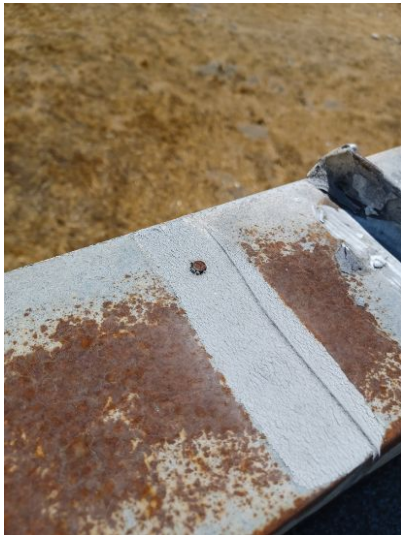
The parapet wall flashing is in poor condition.

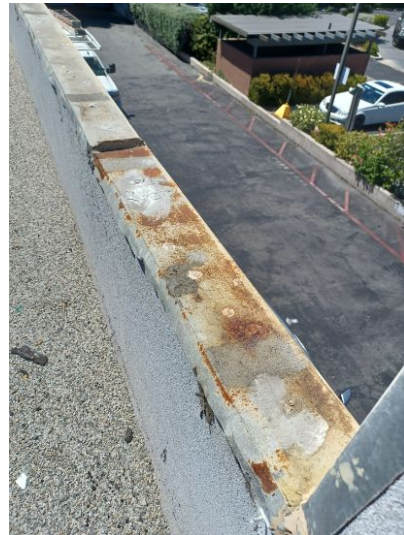
The parapet wall flashing is in poor condition.

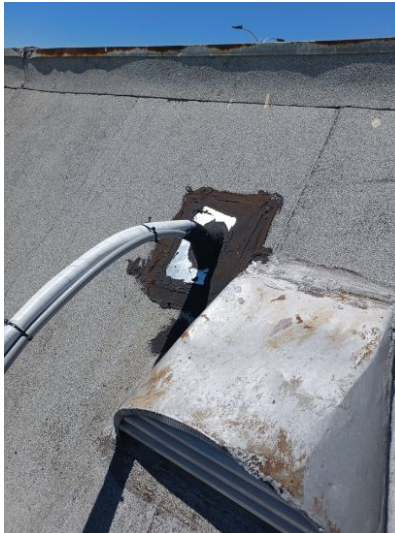
The flashing around the rooftop heating/cooling system is only mastic around the edges which is not a reliable long term seal. This will be a higher maintenance item.

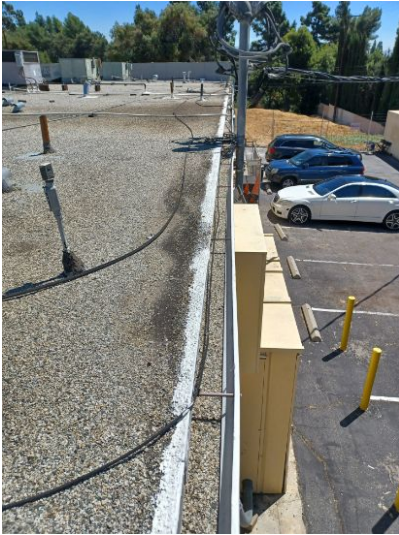
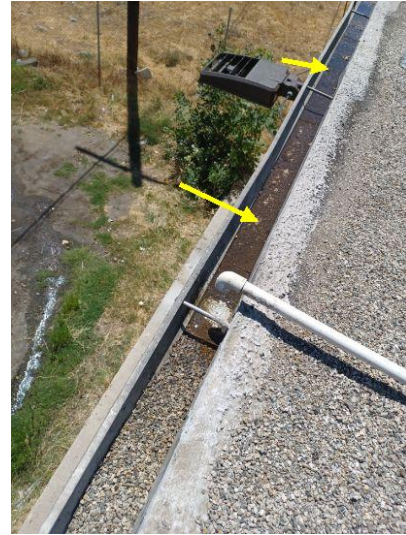
There are areas where the gutter system is filled with debris and needs to be cleaned out. This includes all accumulated roof debris on the roof itself

There are rusty areas in the gutter system

The gutter is sloped improperly and water will not fully drain out of it
