COMMERCIAL INSPECTION REPORT

1234 Main Street, Los Angeles, ,

Inspector: Garrett Martell CMI

Date of Inspection: 8/17/2023

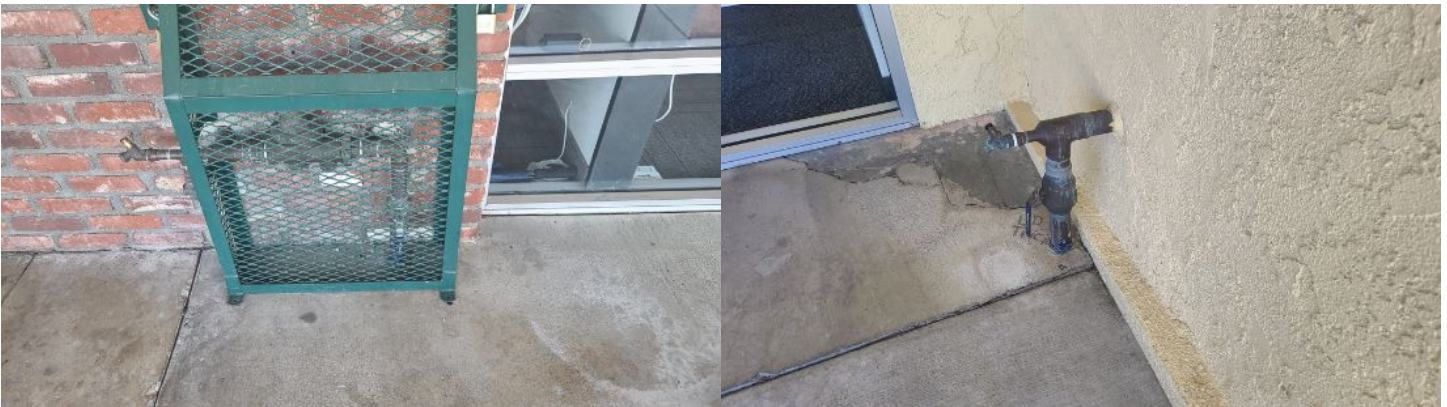
Copper piping is viewed coming out of the ground by the building and as the main line runs underground from the street to the building, this appears to be the main water line.

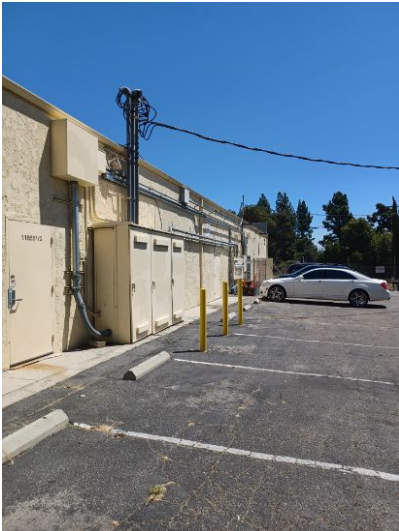
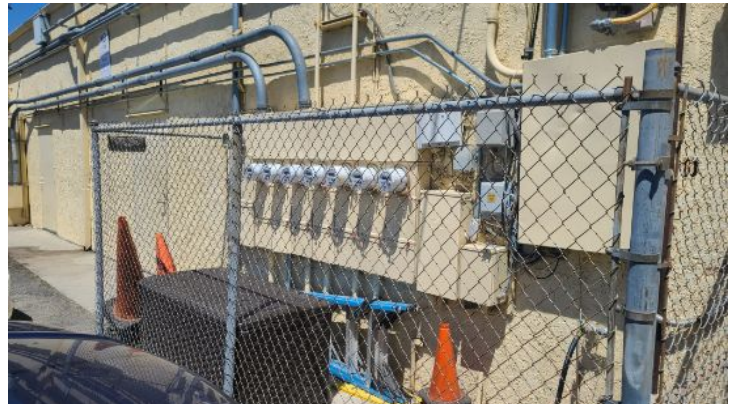
The panel cover is missing inside a few of the electrical boxes at the rear building and the live wiring and circuits are exposed when the outside cover is opened

This panel is an older Federal Pacific system which have been known to have breakers that fail to trip properly when compared with similar panels of the same age and considered a potential fire safety concern, further evaluation is recommended by a licensed electrician to that any repairs or replacements may be made

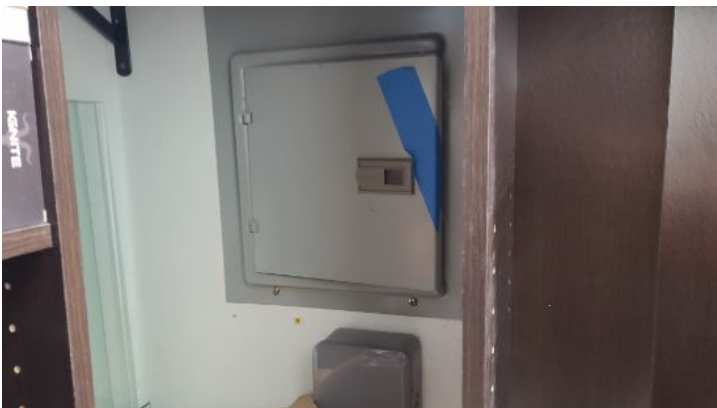
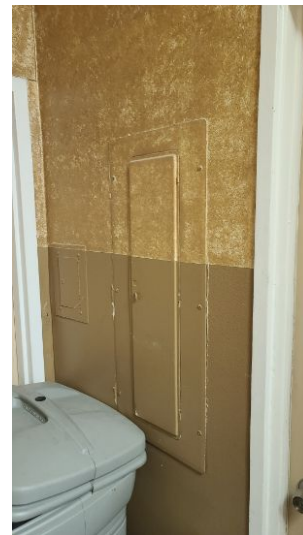
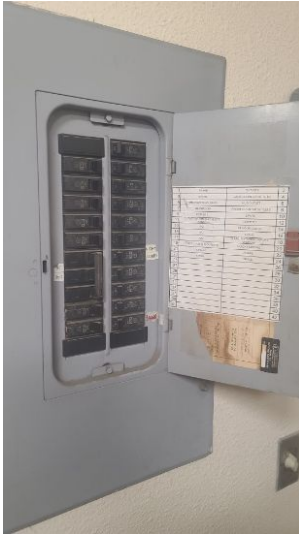
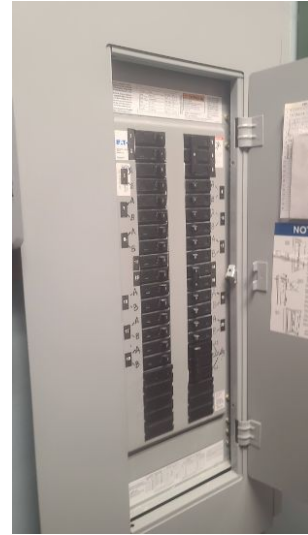
Each unit has its own panel inside near the rear access door.

The wiring in the building consists of plastic coated wires

This was mostly not inspected. The interior panels and wiring is the responsibility of the tenant.

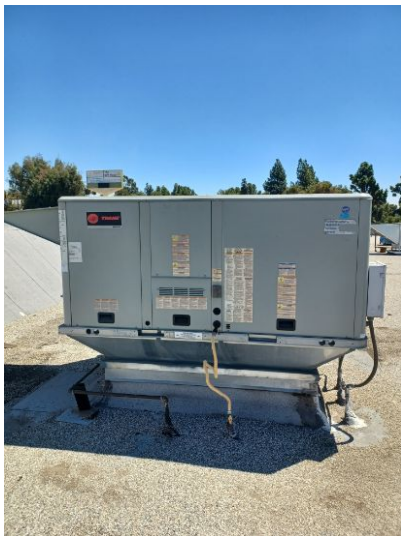
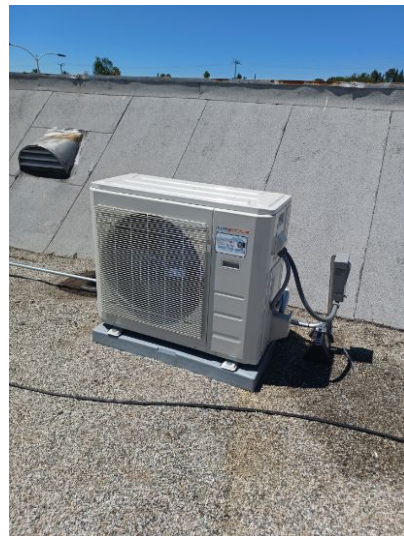
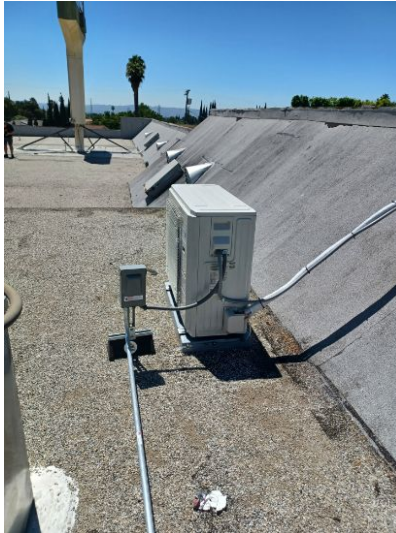
The heating is done by a heat pump in some areas. This is an all electric system that has a condenser that pumps the refrigerant in one direction to cool the building and it goes in reverse to heat it

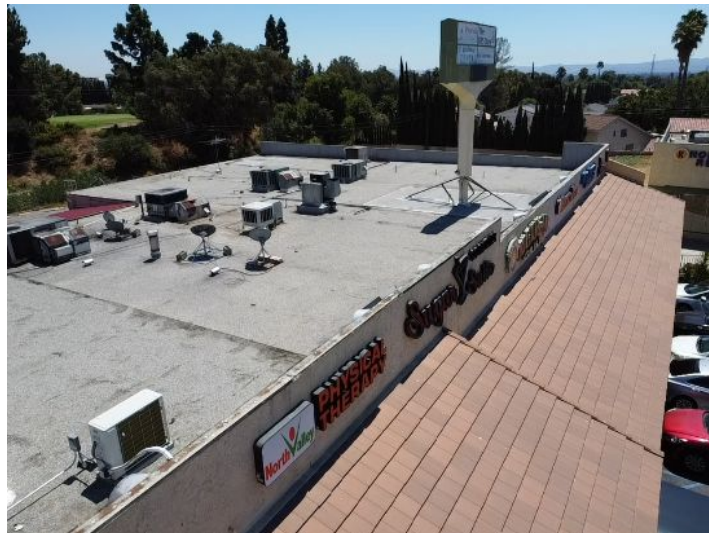
The roof surface contains built up layers of roofing paper with tar and gravel on top of it

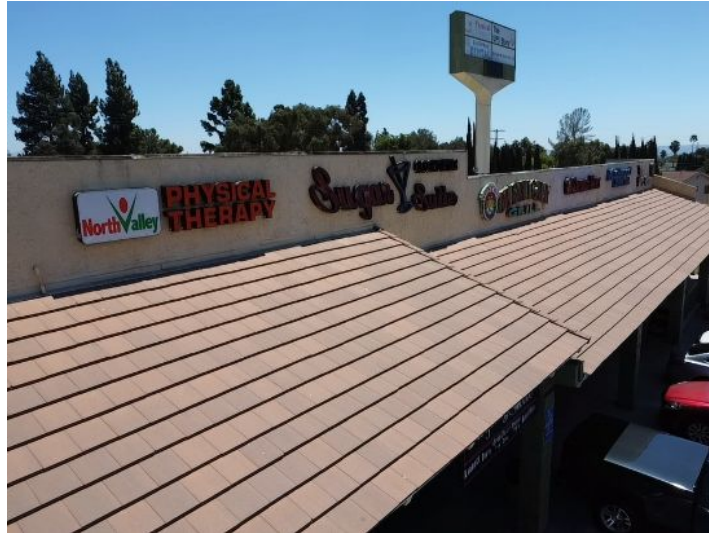
The roof was walked on to inspect it.

There are bubbled areas of roofing material. This could be an indication that some moisture has gotten under the material or that the sheathing installed under shingles is deteriorated or poorly installed.

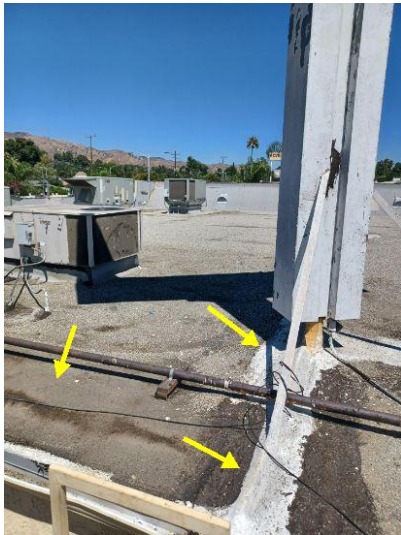
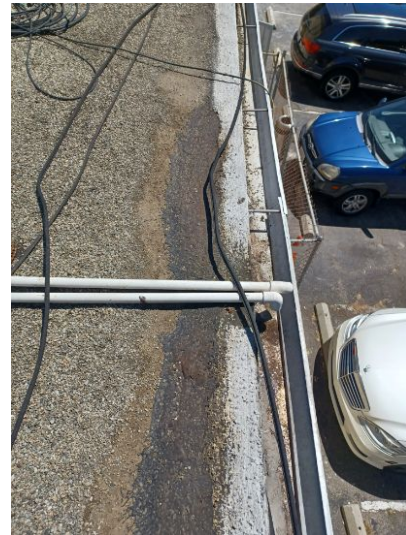
Starbucks Building

There are bubbled areas of roofing material. This could be an indication that some moisture has gotten under the material or that the sheathing installed under shingles is deteriorated or poorly installed.

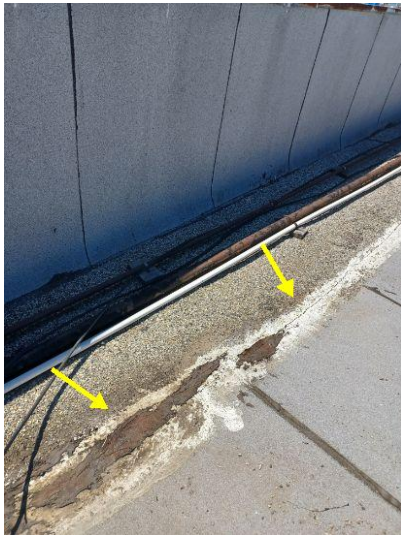
Mexican Grill Building

There are patches on the roof, these are a possible indication that there have been problems with the roof at some point in time. The seller could be consulted on the past of this area.

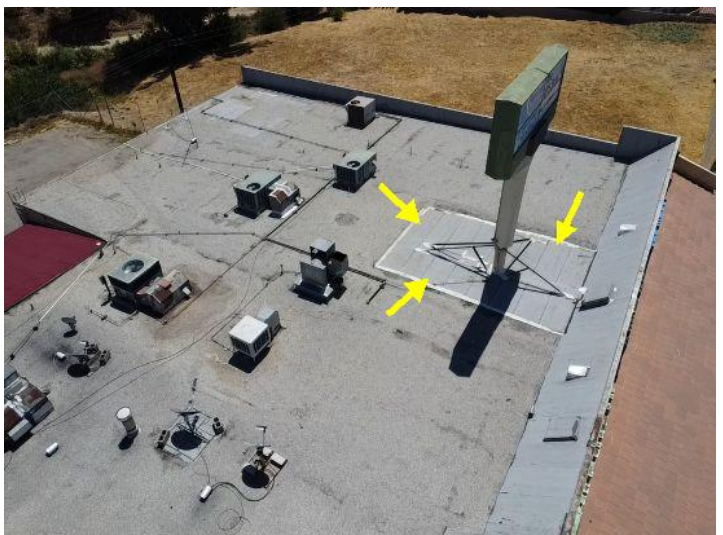
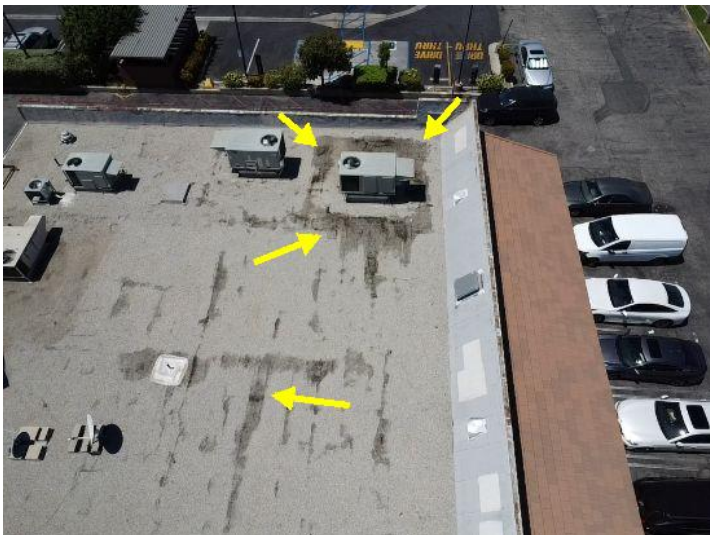
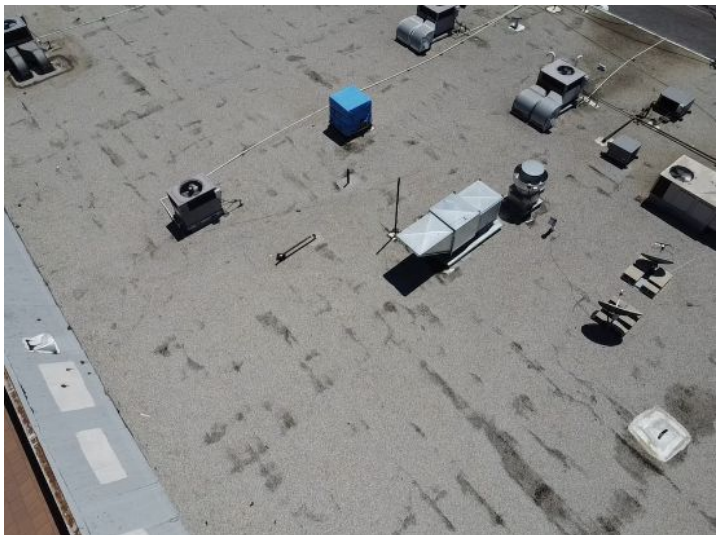
The metal flashing is rusting and corroded in areas

The flashing around the rooftop heating/cooling system is only mastic around the edges which is not a reliable long term seal. This will be a higher maintenance item.

The parapet wall flashing is in poor condition.

The flashing is not standard and may not be a reliable installation, it will require high maintenance to ensure that it remains leak free

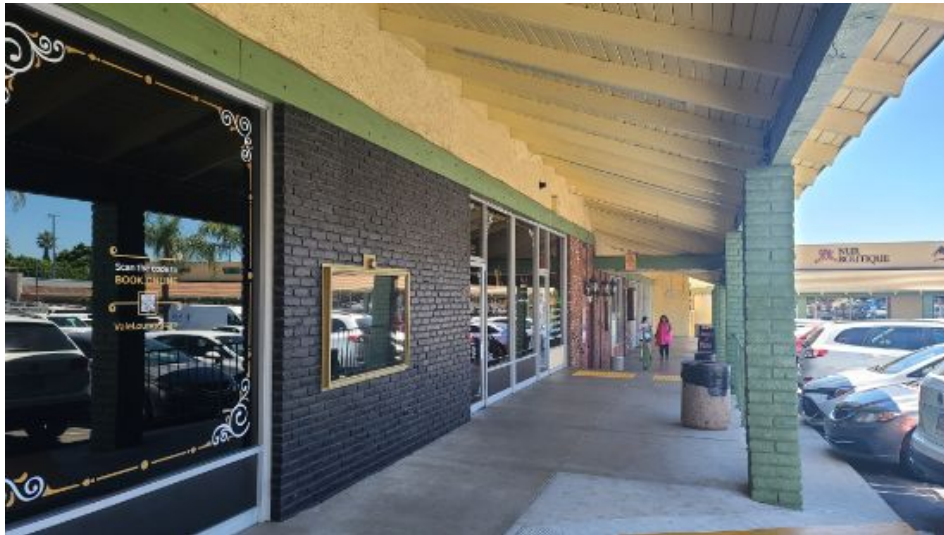
The exterior surfaces of the main building are a combination of different materials.

A visual inspection of the exterior wall covering condition found it to be in a serviceable condition at time the of inspection.

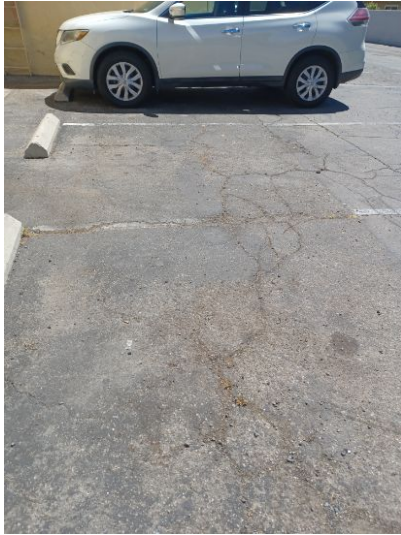
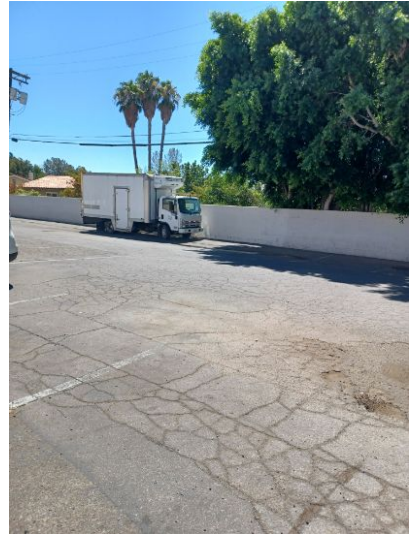
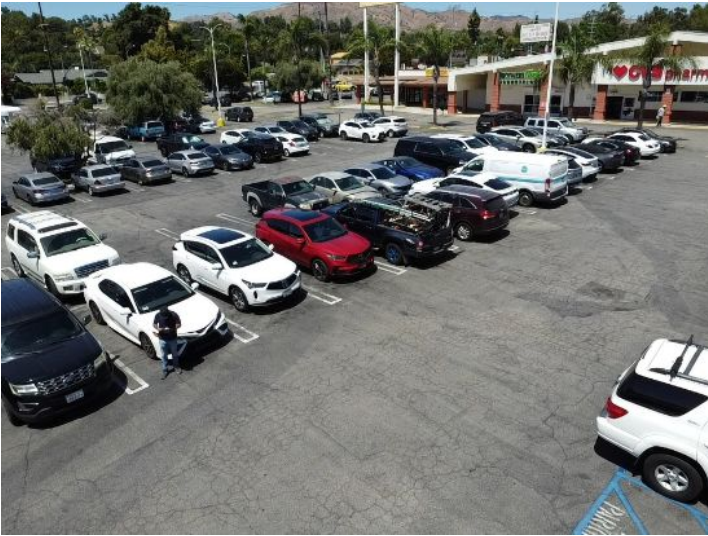
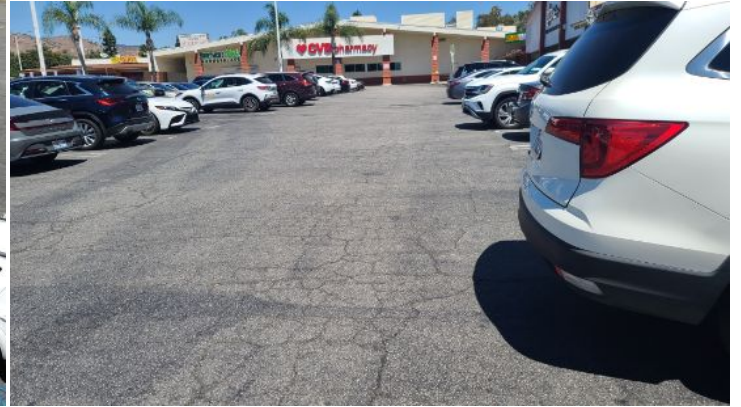
There are significant cracks and shifted areas of the walkways.

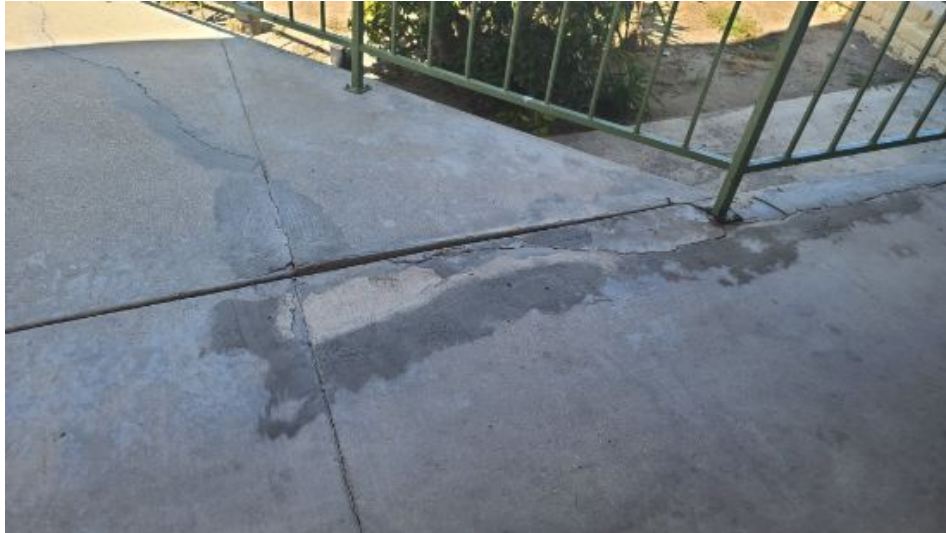
Flat site

A visual inspection of the site drainage and slope found it to be in a serviceable condition at time the of inspection.
